# Effectiveness of Metal and Concrete Pipe Currently Installed in Missouri (Phase 2)

**FINAL REPORT**

RI07-058

**January 2008**

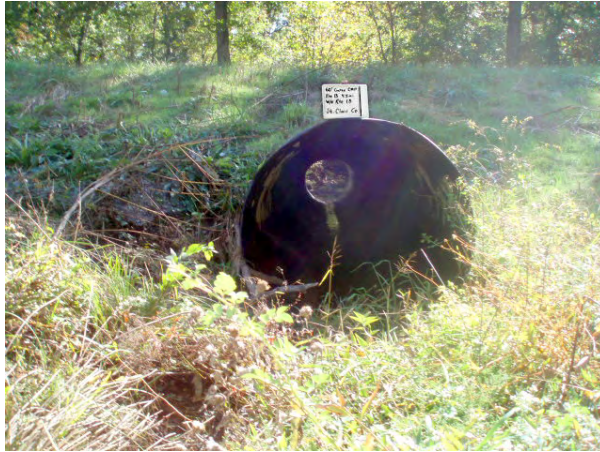
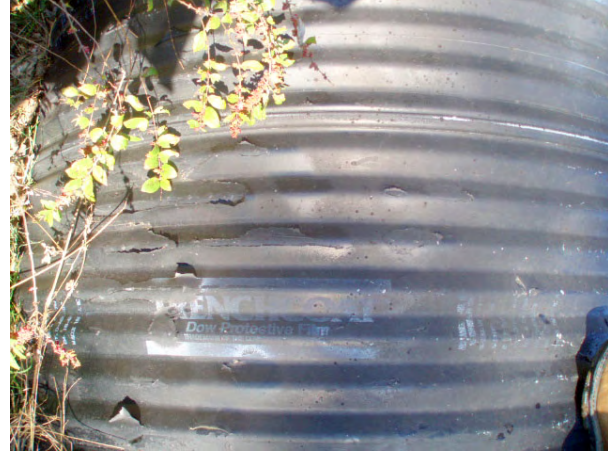
60" PCO pipe, Rt. B St. Clair Co., 4.5 miles W. Rt. 13, installed 1997. Polymer coating flaking off exposed end of pipe due to UV rays.

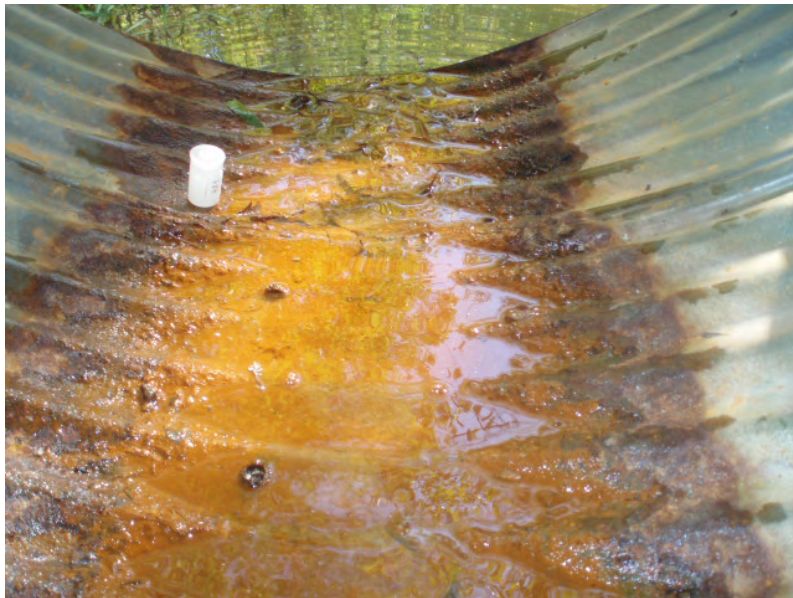
60" PCO pipe, Rt. B, St. Clair Co., Polymer Coated CMP placed in 1997, invert rusted and pitted, 10% section loss in 10 years.

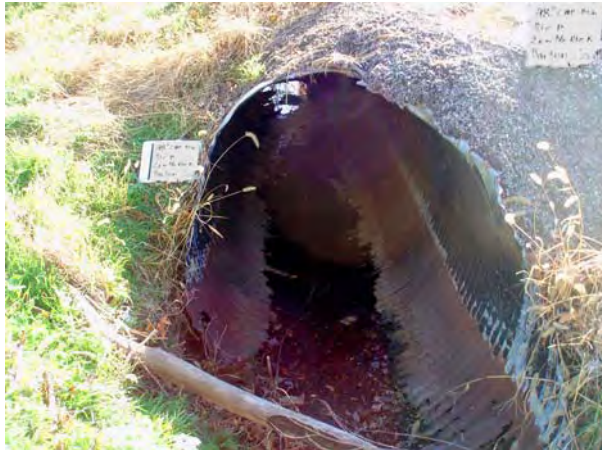
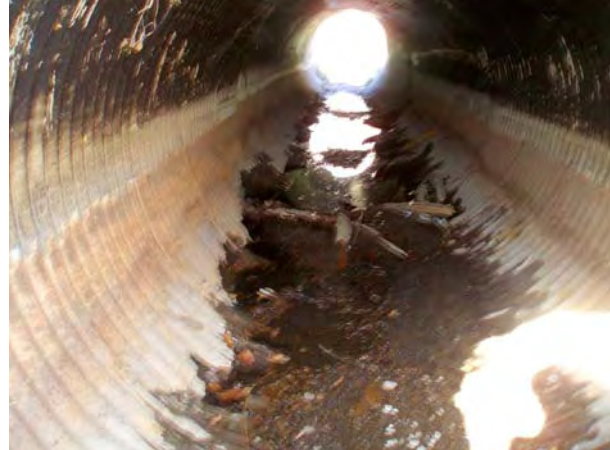
Rt. P, Barton Co., 1960, 48" Bit/Alz pipe, Bitumen and Aluminum coating worn off – invert rusted out. Water sample pH=7.2 but must have been low pH runoff in past.

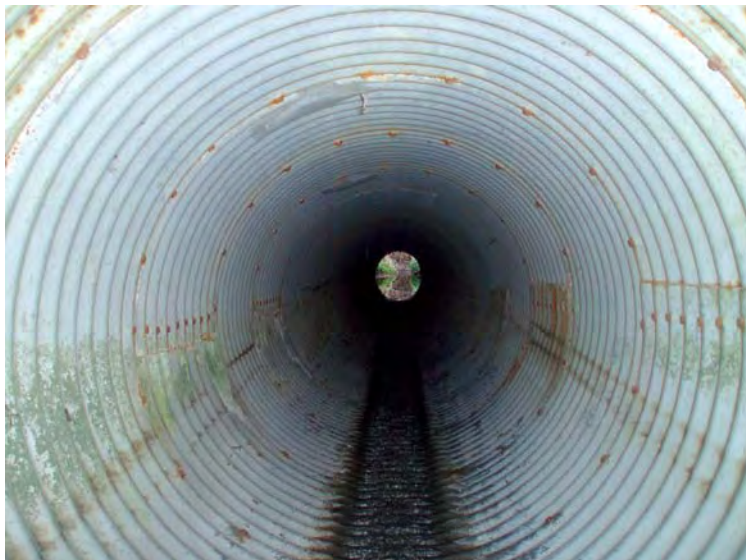
Rt. 246, Nodaway Co., 36"d. ALZ – Original aluminized pipe installed in 1952 with only minor pitting of coating and staining at invert.

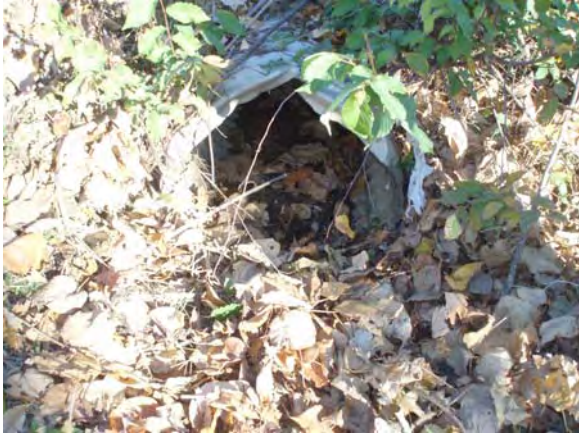
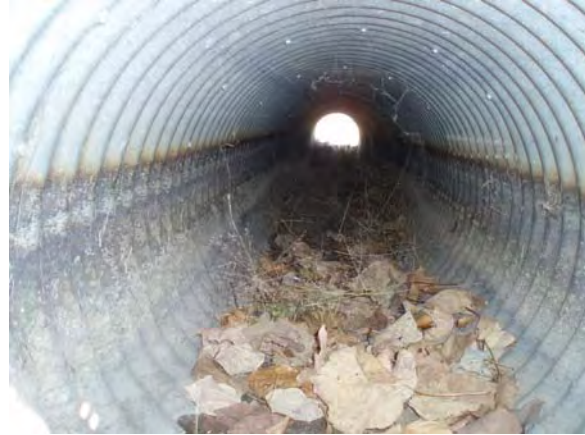
Rt. NN, Barton Co., 1962, 24" Aluminum Alloy – One end mower damaged, stained but no corrosion on invert.

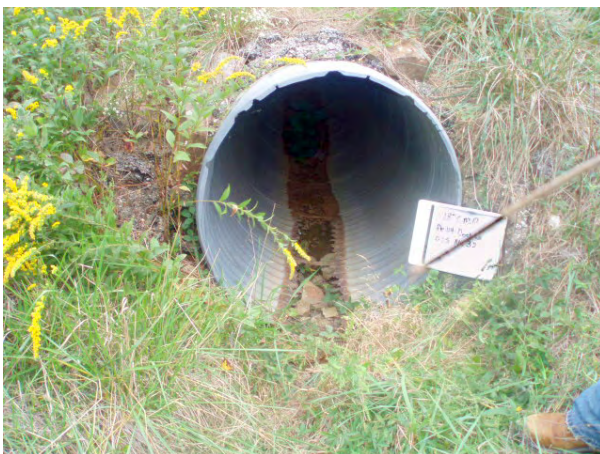
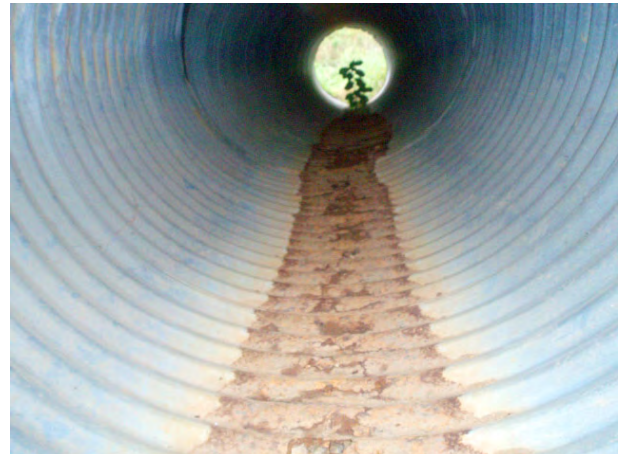
Rt.119, Dent Co., 36" Helical Galvanized Steel – installed 1995 and invert already rusted out the whole length.

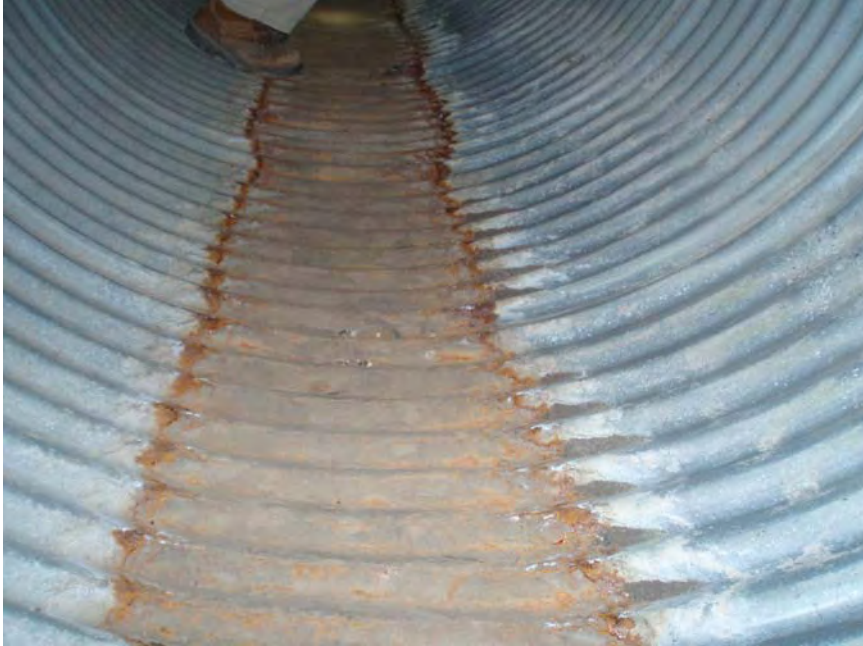
Dekalb Co., Rt. D, 48" d., Helical GSP, installed 1998 – invert rusting and pitting, nine years old.

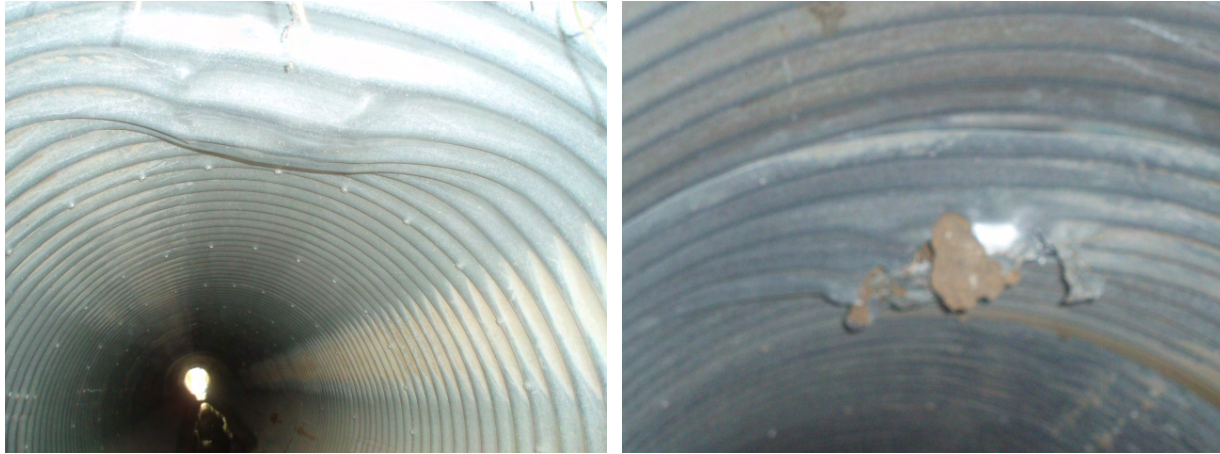
Rt. 61 SBL, Co. Rd. 464, Side Rd. Pipe, Lewis Co. - New 36" riveted GSP –with end crushed in near outlet and hole near inlet end with daylight showing thru.

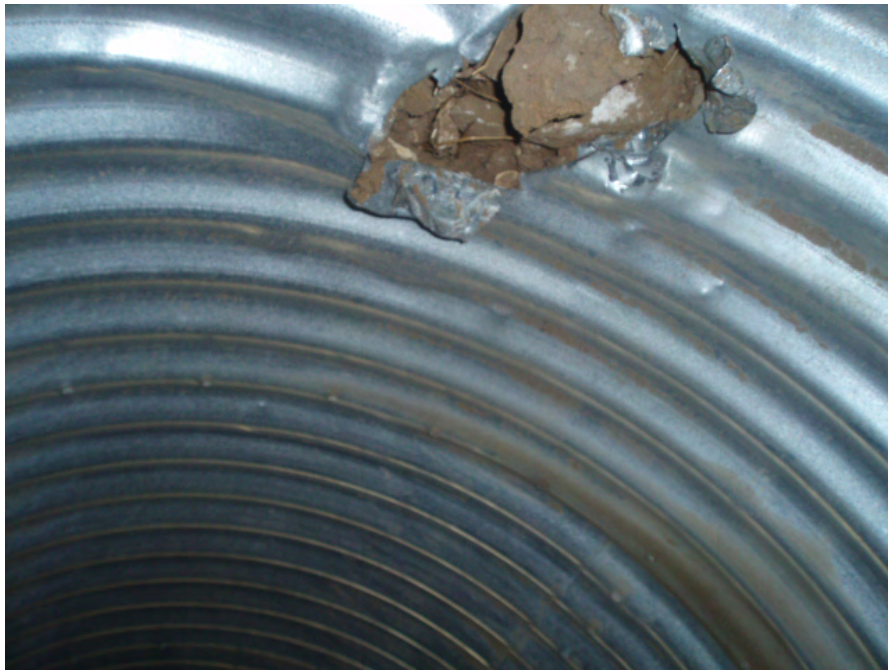
Rt. 61 SBL, Co. Rd. 464, Side Rd. Pipe, 36"d. riveted GSP – 6"diam. hole 2 ft. in from inlet, rocks poking thru.

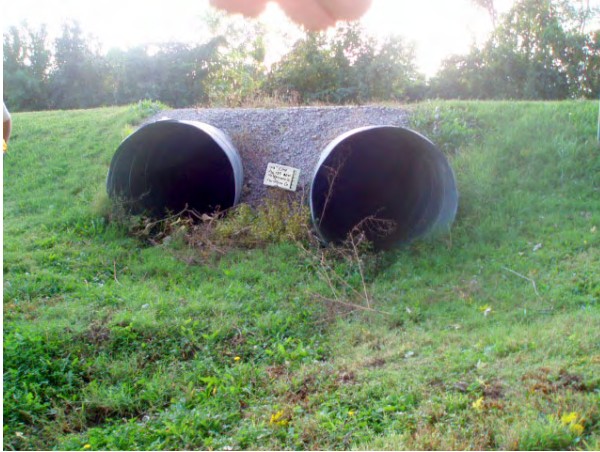
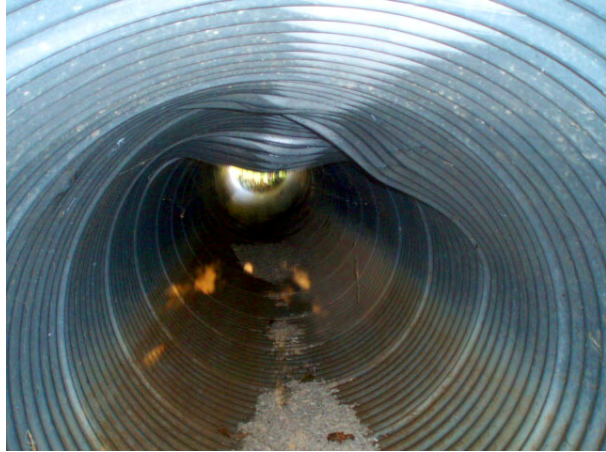
Christian Co., Rt. 125, 8.0 S Co. Ln., 2-48''d. GSP, helical pipe. - Crushed but not torn 4 places.

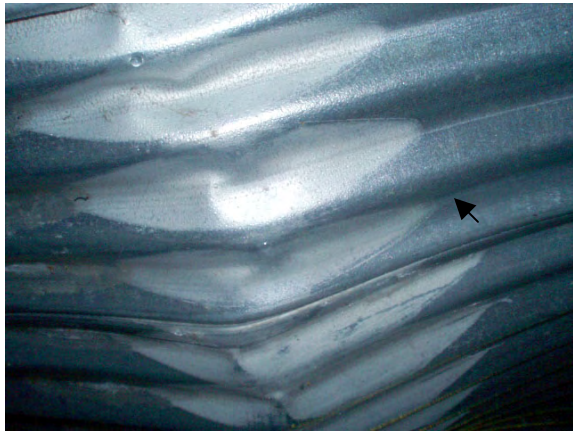
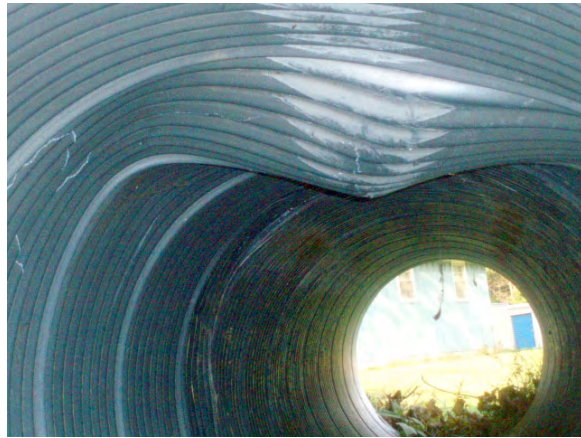
Christian Co., Rt. 125, 8.0 S Co. Ln., 2-48''d. GSP, helical, - crushed on top, 11'' deflection.  
- crushed on top near seam, seam holding.

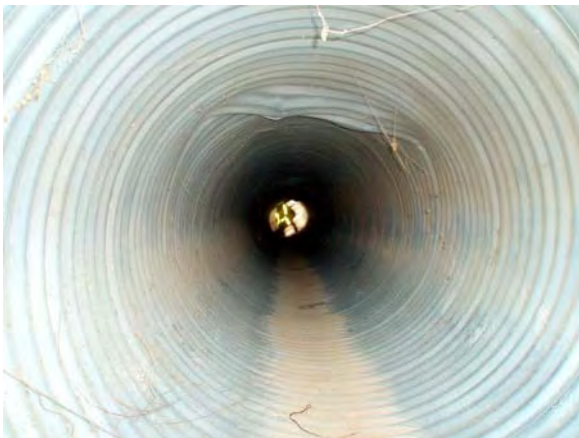
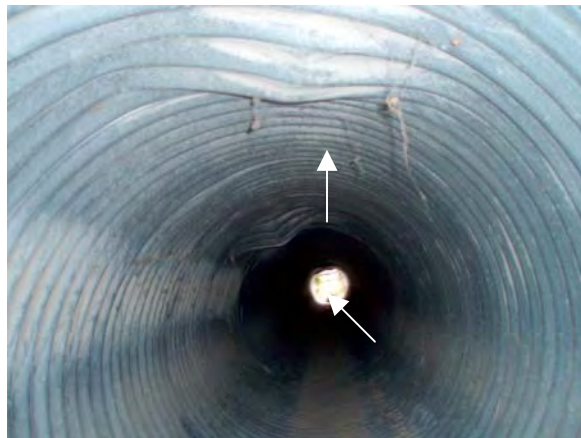
Rt.71, McDonald Co., Sta. 637+09 Lt. -, 36'' Group B –  
worst dent deflected in 5'' at top on seam, and looking from other end - dented two other places at top.

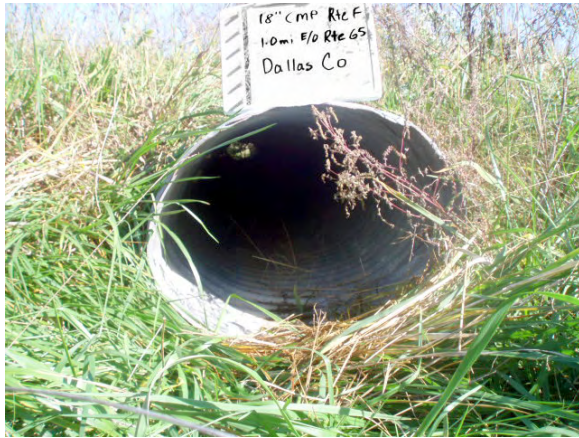
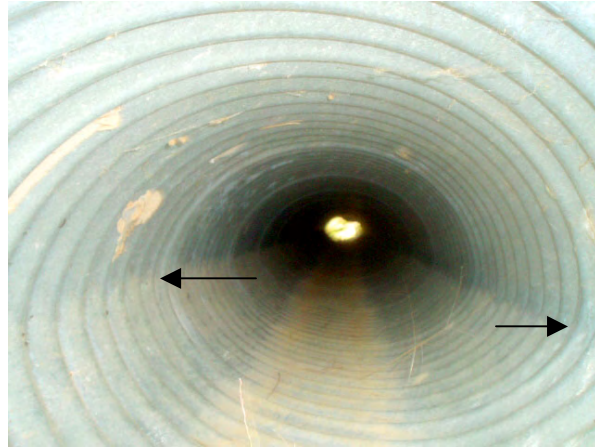
Dallas Co., Rt. F, 18"d. GSP – deflected dimensions are 18" high x 23" wide, inside is bending at different elevations on each side. Assume it is really a 20"d. pipe; Cause - not enough overfill height, vehicle loads transferring straight to pipe.

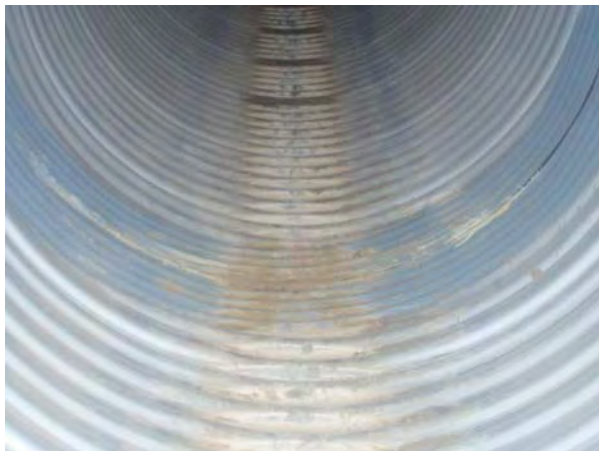
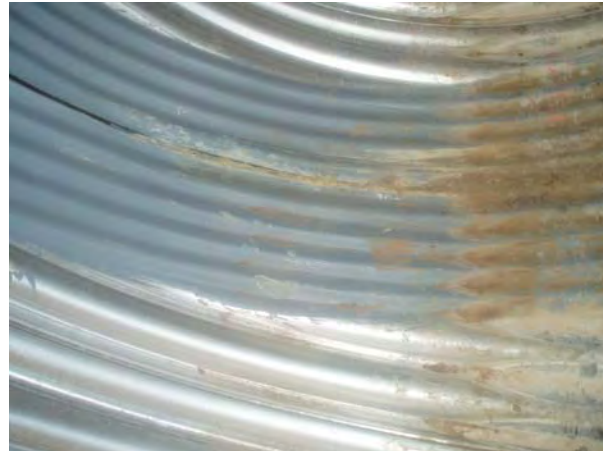
Rt. 50 Cole Co., 72" Helical corrugated pipe – crimped down and re-corrugated approximately 1" deep (close up on rt.). Looks good, has been painted with zinc paint, but the shallow corrugations don't provide much mechanical grab for the connecting bands on the outside of this 6 ft. diameter pipe.

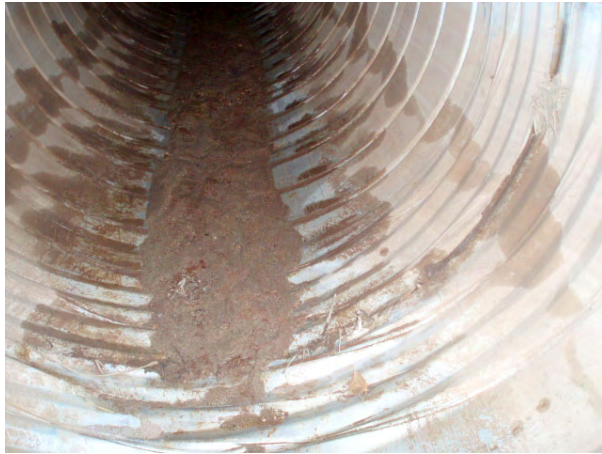
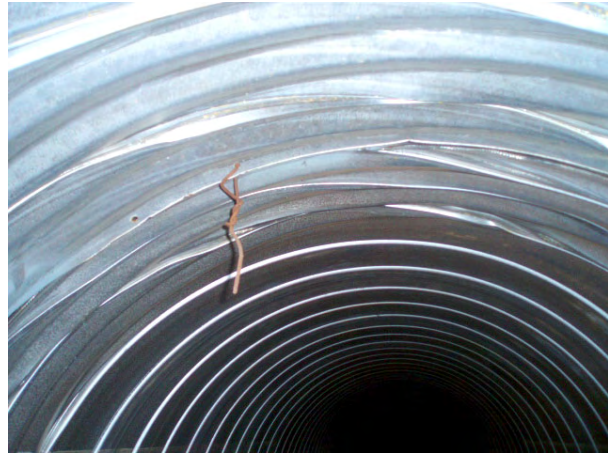
Job J8U0535, Rt. 160, Greene Co., 48" Group B, W. side 0.1 N. of Wadill St. – pipe is helical channel construction, corrugated ends make cleaner joint.

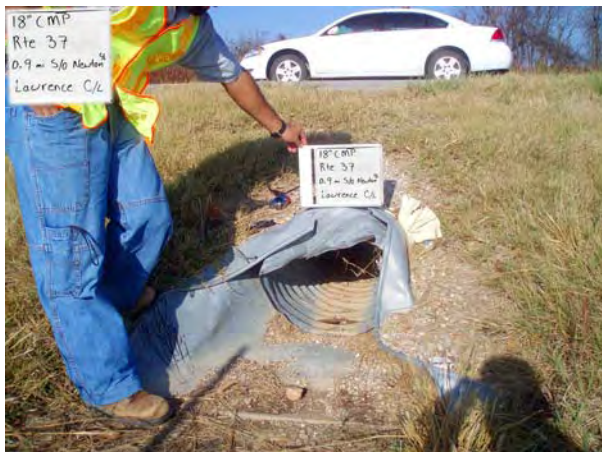
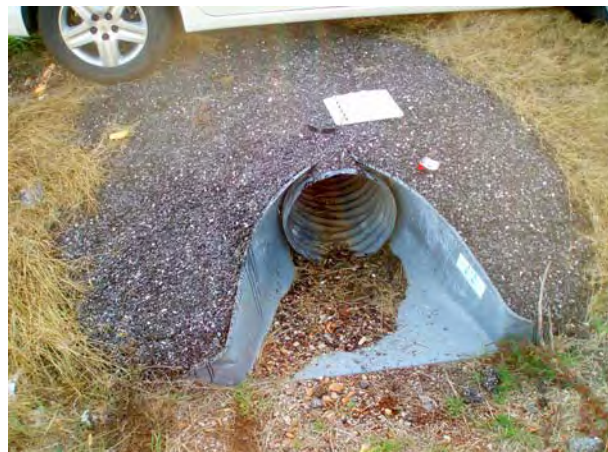
Lawrence Co. Rt. 37, 0.9 S Newton Co. Ln. 18" CMP – crushed pipe end and steel FES, and good backfill around steel FES, other side of road.

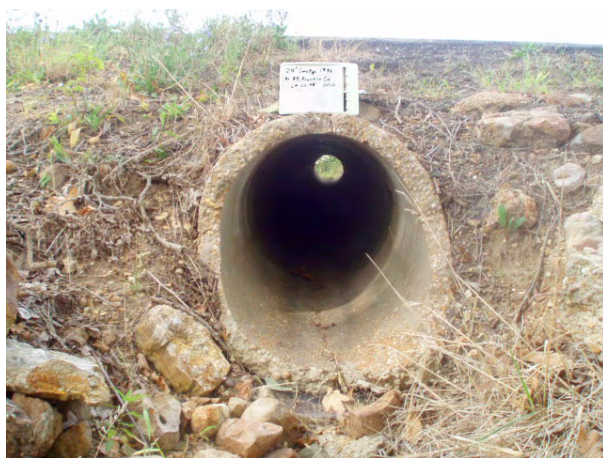
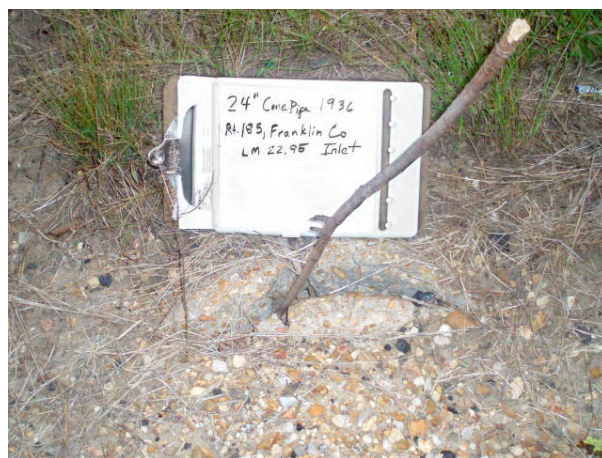
Rt. 185, Franklin Co., 24" d. non-reinforced concrete pipe, 1936 – open gap in pipe with stick in it.

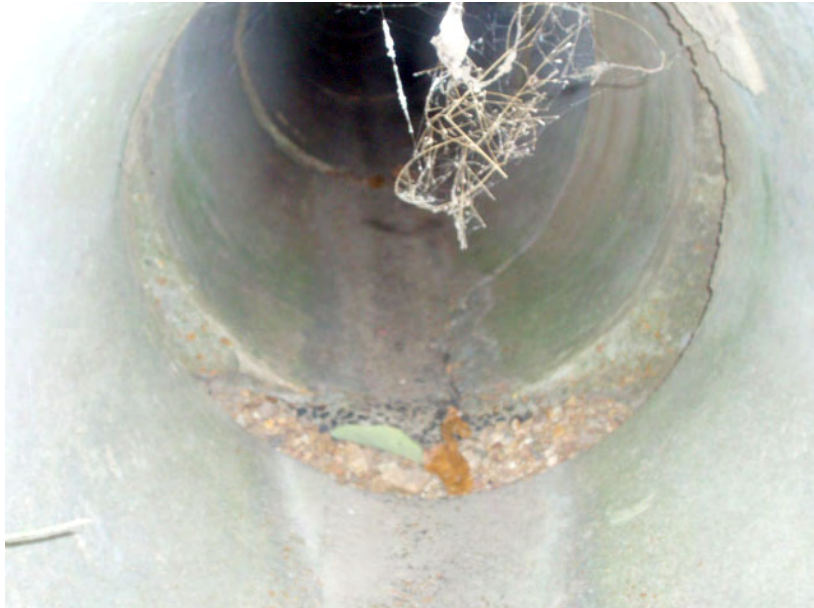
Rt. 185, Franklin Co., 24"d. non-reinforced concrete pipe, 1936 – joints deteriorating.

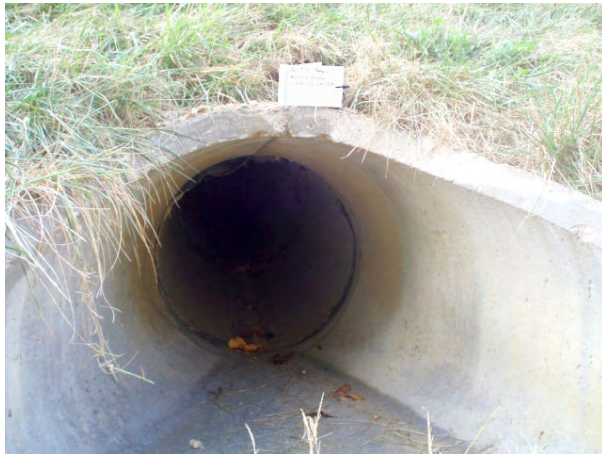
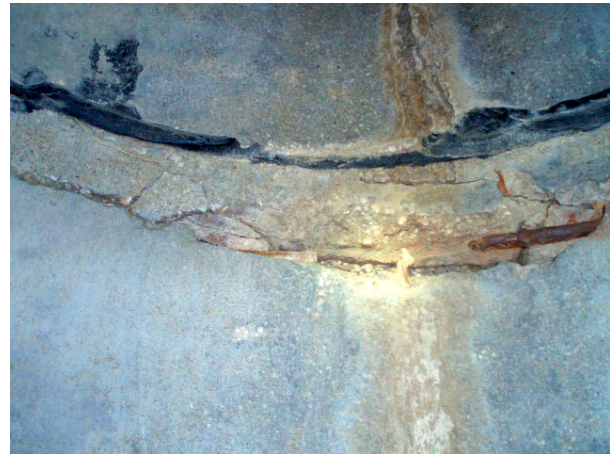
Rt.61, Pike Co., 0.15 Rp.54-61N, 1979, 36"d. RCP- Inlet FES & inlet 1<sup>st</sup> joint deteriorated 6" rebar rusted off.

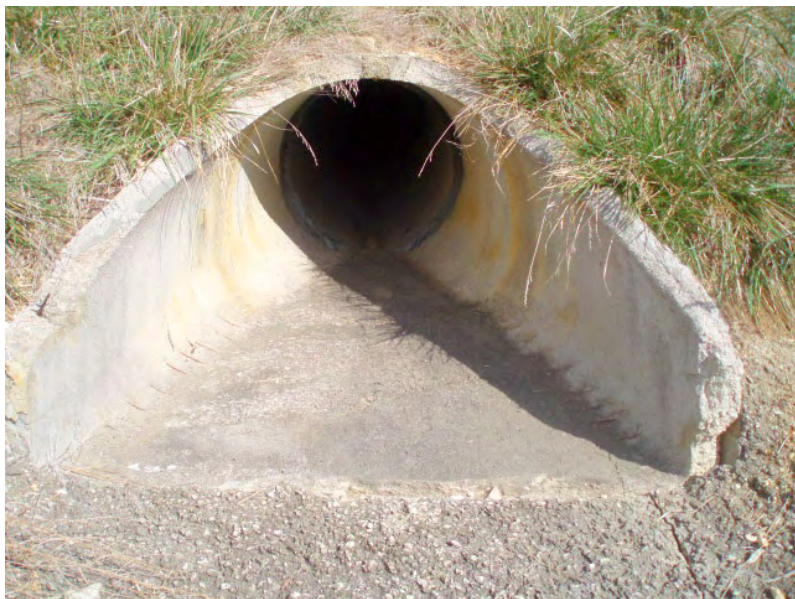
Rt.61, Pike Co., 0.15 Rp.54-61N, 1979, 36"d. RCP-outlet FES, chewed up by mowers

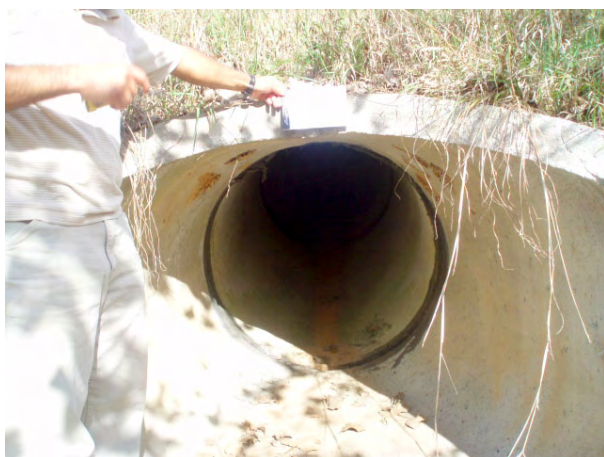
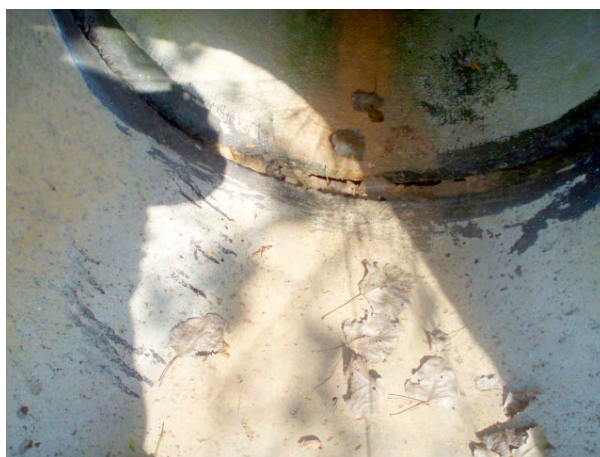
Rt. 61, Pike Co., 1996, 0.7 Ralls Co. Ln., 42" Cl. IV& Cl.III RCP – inlet FES & 3" gap at joint between FES and 1<sup>st</sup> section pipe.

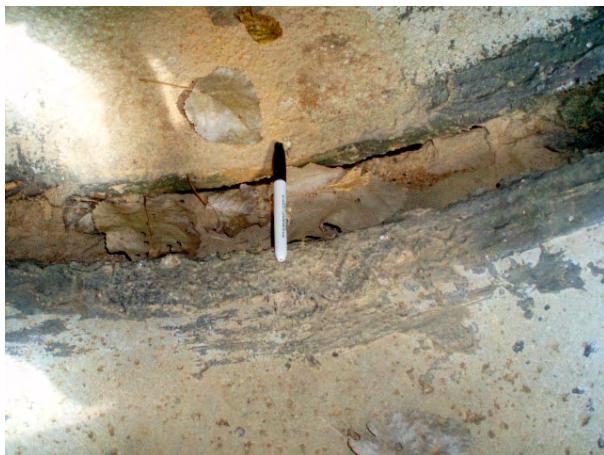
Rt. 61, Pike Co., 1996, 0.7 Ralls Co. Ln., 42" Cl. IV& Cl.III RCP – 4" gap @ outlet FES

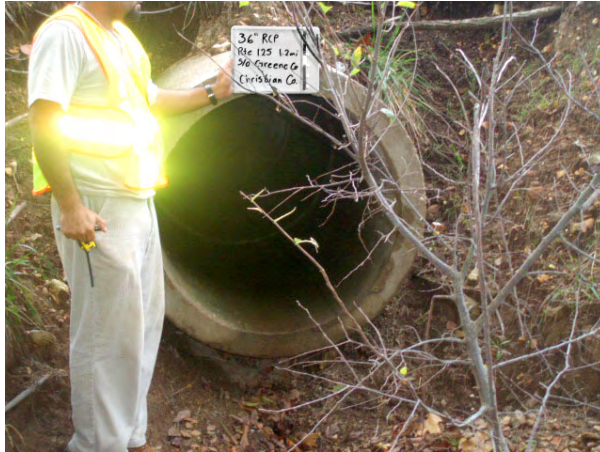
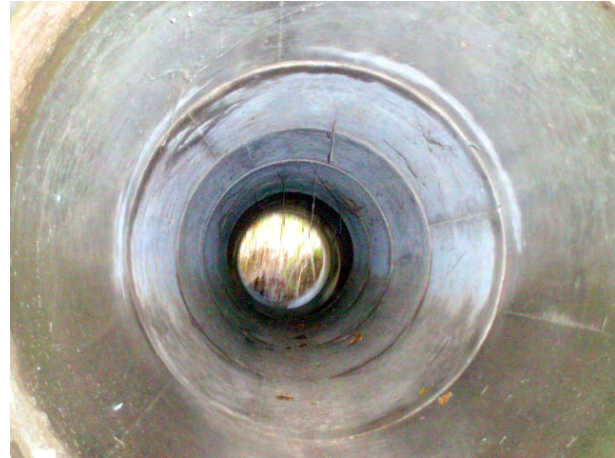
Rt. 125, Christian Co., 1.2 S Greene Co Ln, 1935, 36" RCP – 1935 installation, joints rated 7 condition because 1" gap and open joint at inlet section. 4" gap at joint but not open at outlet end, all interior joints of 4' sections tight.
